Prüfbericht - Nr.: 19002416 003 <i>Test Report No.:</i>		Seite 1 von 3 <i>Page 1 of 3</i>
Auftraggeber: <i>Client:</i>	SEMPERIT TECHNISCHE PRODUKTE GESELLSCHAFT M.B.H.,A-1031 VIENNA MODECENTERSTRASSE 22, AUSTRIA	
Gegenstand der Prüfung: <i>Test item:</i>	Refer to next pages	
Bezeichnung: <i>Identification:</i>	COTTON FLOCK BEADING CHLORINATE	Serien-Nr.: <i>Serial No.:</i> N/A
Wareneingangs-Nr.: <i>Receipt No.:</i>	1203009233-1	Eingangsdatum: <i>Date of receipt:</i> 24 March 2011
Prüfört: <i>Testing location:</i>	TÜV Rheinland Thailand Ltd. Global Technology Assessment Center Bangkok (GTAC BKK) Ladkrabang Industrial Estate 123/1, Floor 1-2 Soi Chalongsung 31, Lamplatew, Ladkrabang, Bangkok 10520 Thailand	
Prüfgrundlage: <i>Test specification:</i>	Commission Regulation (EU) No 10/2011 on plastic materials and articles intended to come into contact with food Chemical requirements / parameters selected by customer

Item:	Sempertip/ Sempervelvet	
Country of Origin:	Thailand	
Test period:	24 – 31 March 2011	
Delivery Condition:	Apparent good	
The report 19002416 003 supersedes report 19002416 002.		
Abkürzungen:	P(ass) = entspricht Prüfgrundlage F(ail) = entspricht nicht Prüfgrundlage N/

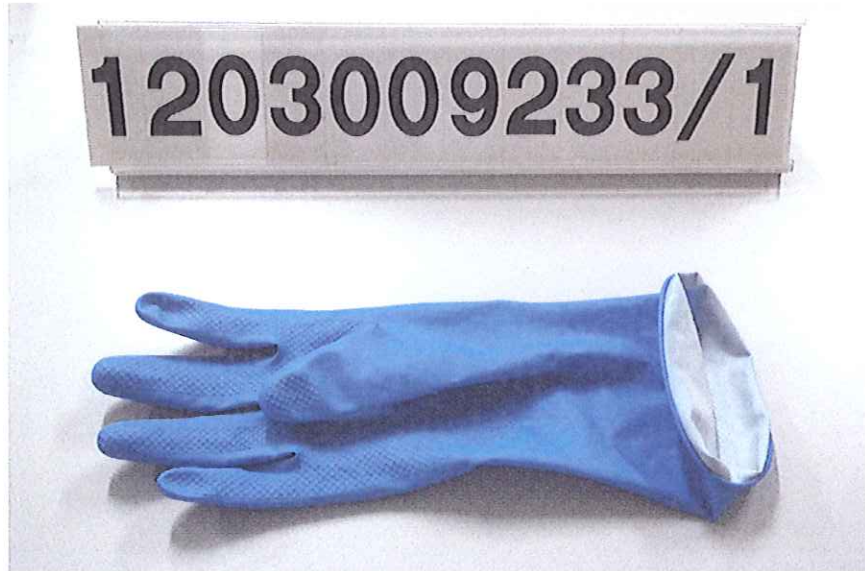
Sample photo:

Material No.	Material	Color	Description/ Location
M001	Rubber	Blue/white	Refer to photo
